REYNA ANTÚNEZ 211 S MESA DR MESA, AZ 85204

Following the recent wind event, shingles were blown off in multiple, separate areas of the roof. Based on our inspection, a simple repair or partial replacement would not provide a durable or compliant solution for the reasons below:

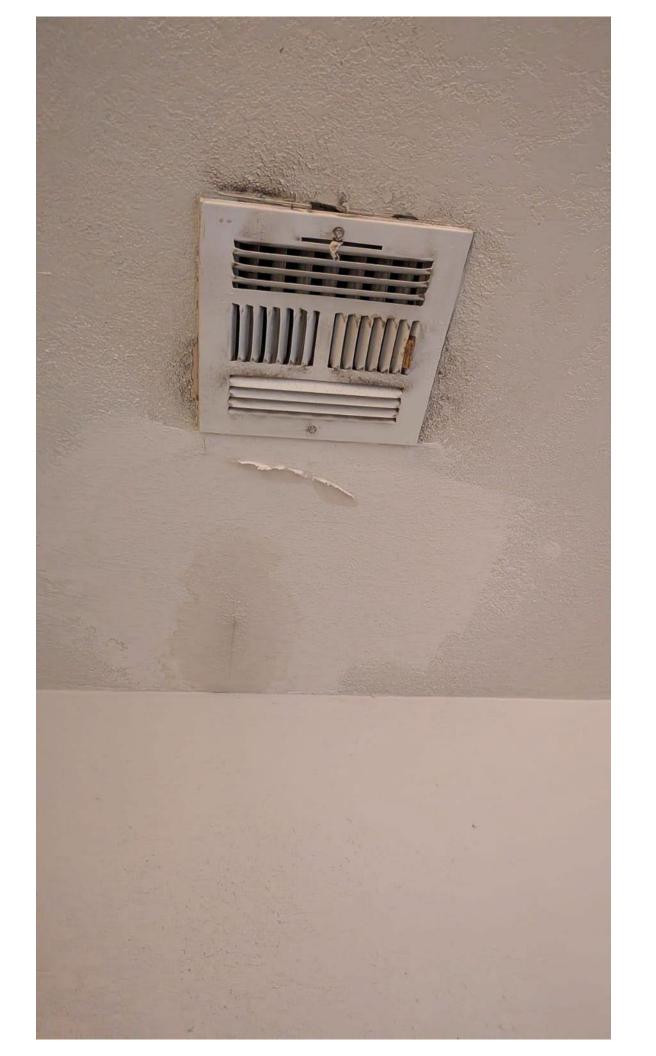
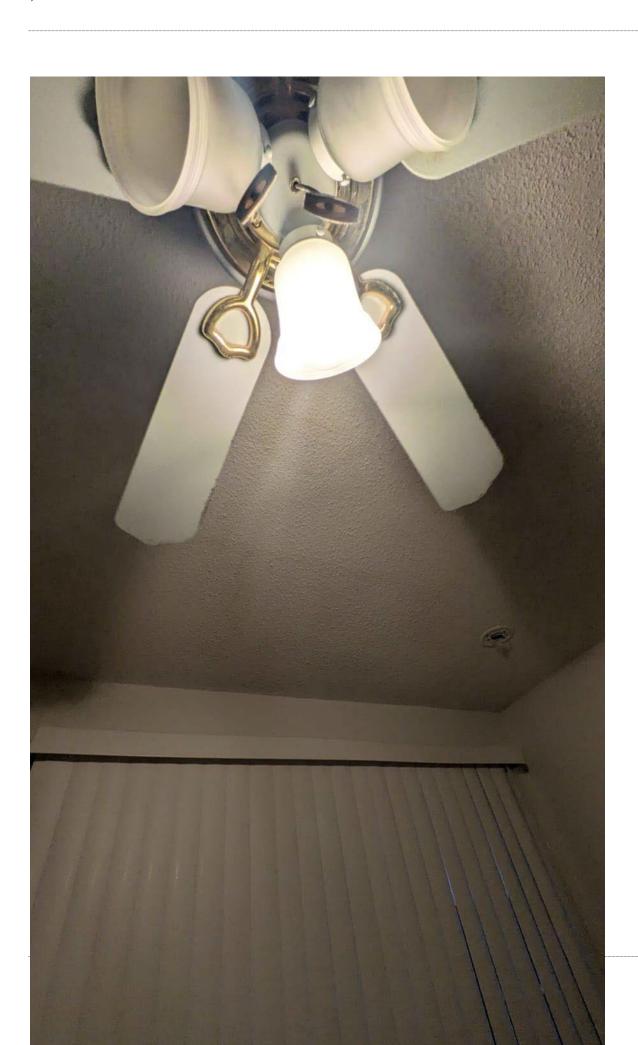
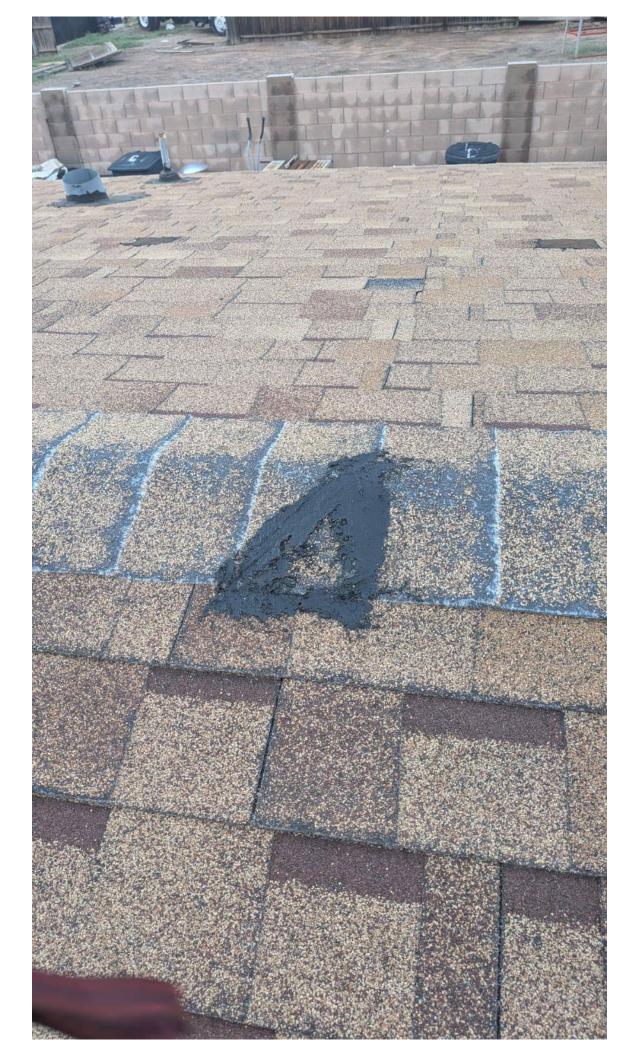
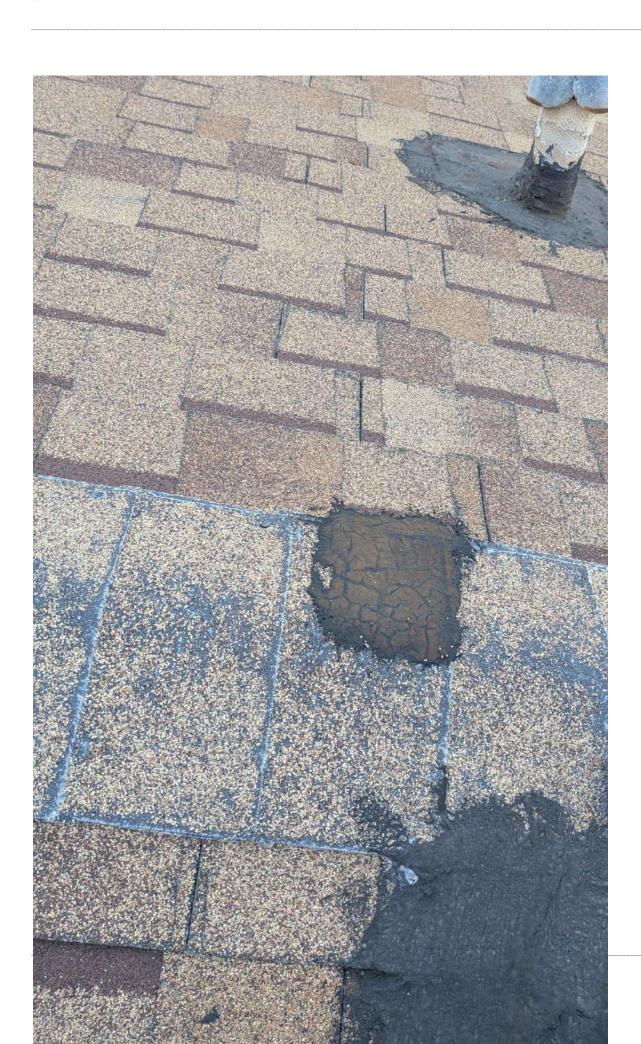
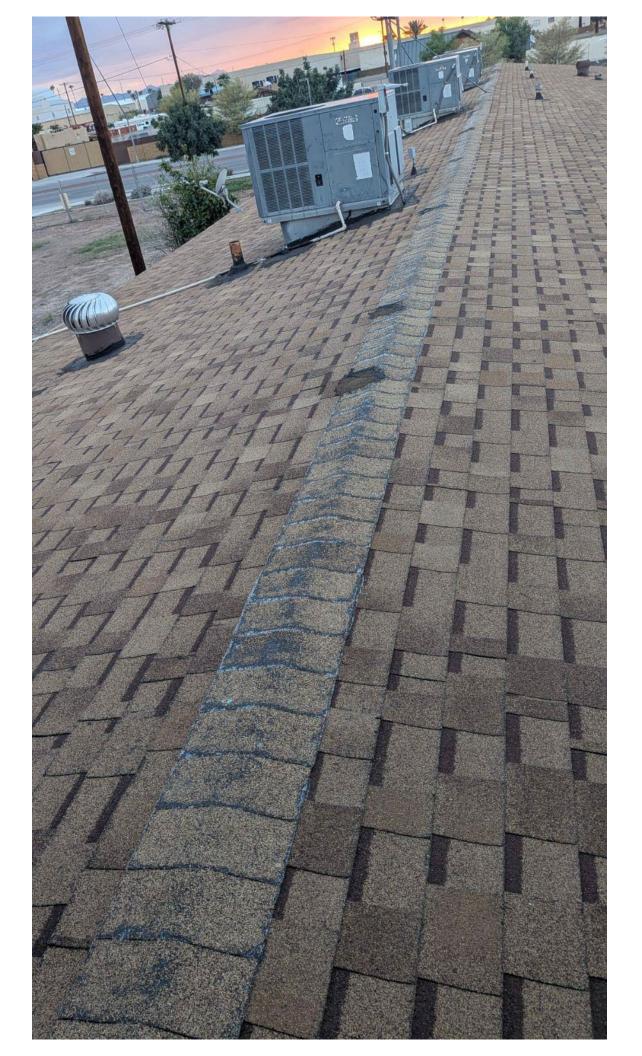
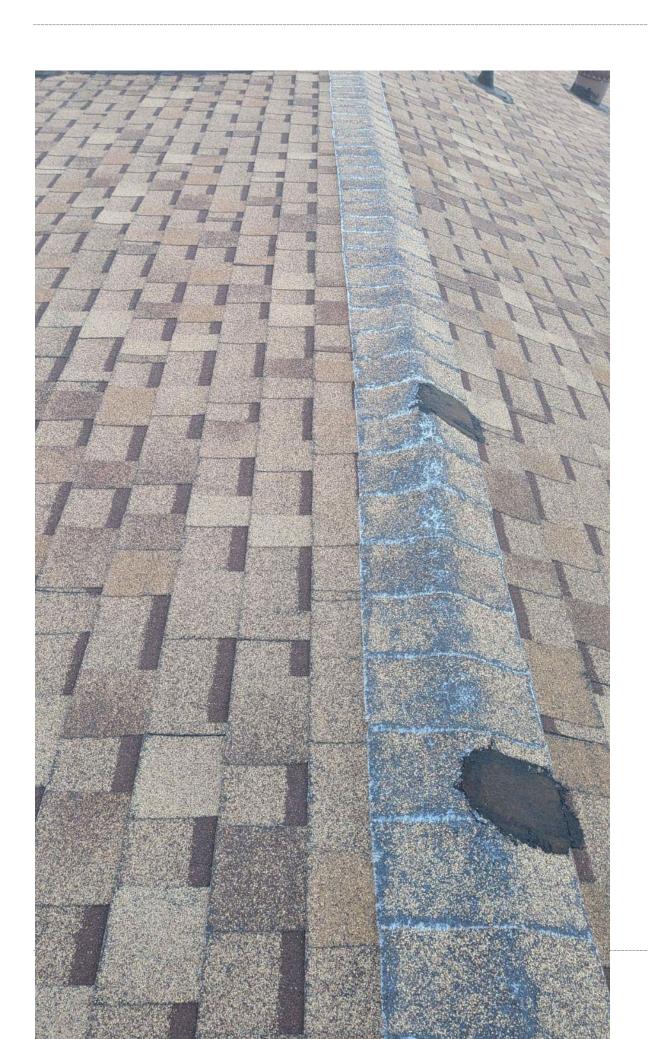
Displacement across several sections indicates a systemic failure of the shingle adhesive/seal and fastening system. The damage is not isolated, and similar failures are likely to recur even if individual areas are patched.

Wind strong enough to remove shingles typically lifts and weakens adjacent shingles, underlayment, and fasteners. Much of this damage is not visible during surface-level repairs, creating a high risk of future leaks and moisture intrusion if only spot repairs are performed.

In light of the above, we recommend full replacement of the affected slopes (or full roof replacement, as appropriate) to achieve a durable, code-compliant, and warranty-aligned outcome. **See attached supplementary images.**
